**Oregon Department of Transportation  
Bridge Inspection Report**

<b>District :</b> 10	<b>Structure :</b> COI Canal, Gribbling Rd	<b>Bridge ID :</b> 17C30
<b>Fac Crossed :</b> COI CANAL	<b>Owner :</b> County Hwy Agency	<b>Fac Carried :</b> GRIBBLING ROAD
<b>Suff Rating :</b> 17.0	<b>County :</b> Deschutes	<b>Mile Point :</b> 1.00 mi
<b>AC Depth :</b> 0.00	<b>Record Type :</b> 1	<b>Insp Date :</b> 02/27/2021
<b>Bridge Length :</b> 40.00 ft	<b>Insp Freq :</b> 12	<b>Inspector 1 :</b> JOHN HARMS (C0079)
	<b>Bridge Width :</b> 13.00 ft	<b>Inspector 2 :</b>

Bridge NO: 17C30  
Insp Date: 02/27/2021

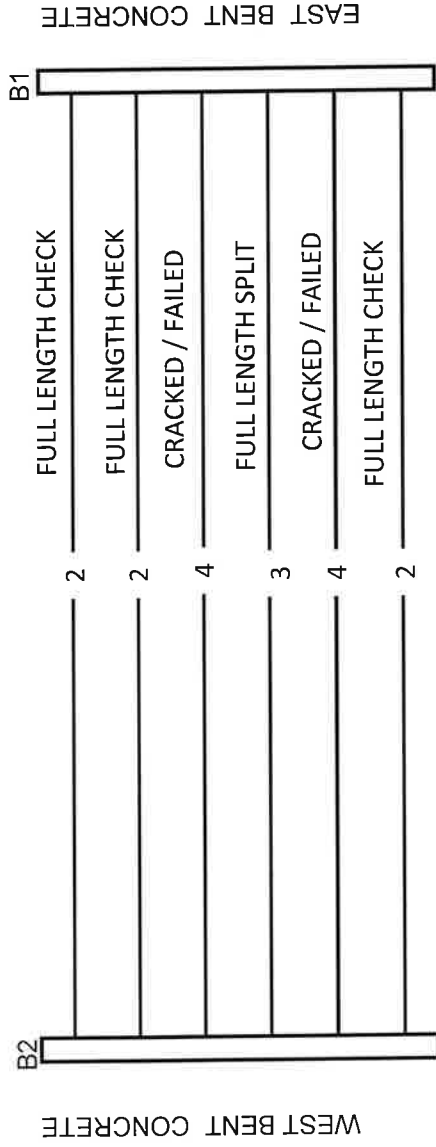
# TIMBER BORING REPORT

COUNTY: DESCHUTES  
 BRIDGE NO.: 17C30  
 NAME: COI CANAL, GRIBBLING RD  
 OWNER: COUNTY  
 CONDUCTED: 2-27-2021    FREQUENCY: 2 YRS    NEXT: 2-1-2023
