ADDENDUM NO. 1

HAMEHOOK RD BRIDGE #17C32 REPLACEMENT

**GEOTECHNICAL EXPLORATION REPORT
HAMEHOOK ROAD BRIDGE
BEND, OREGON**

Wallace Group Project No. 23106-1

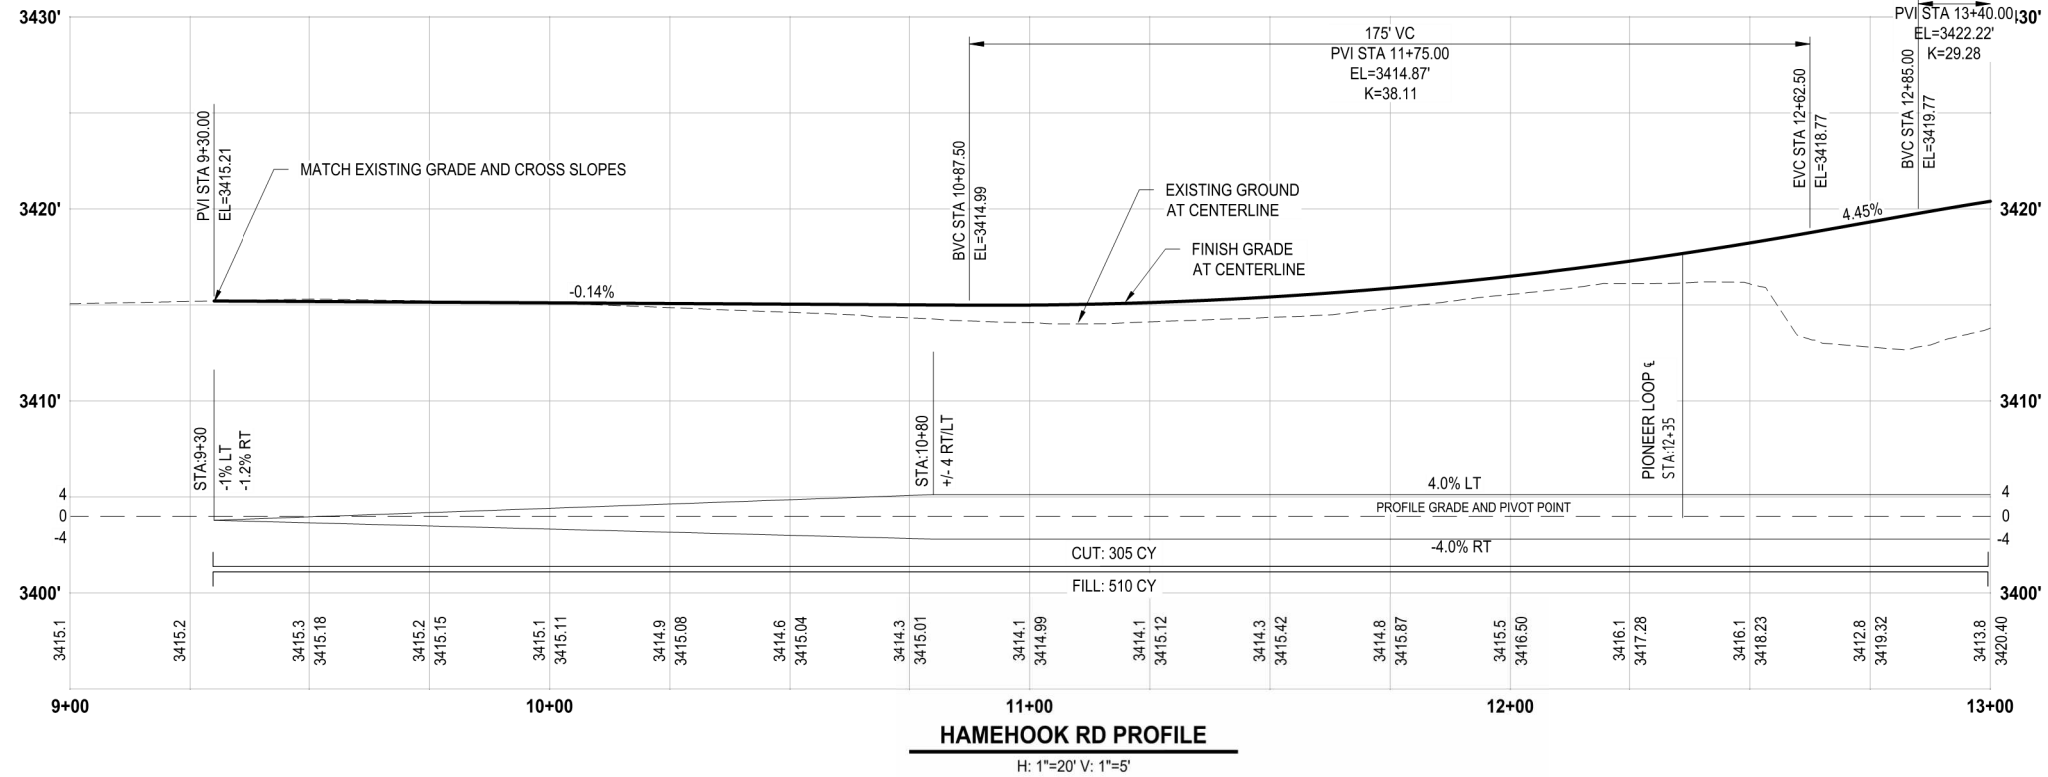
DRAWING NO.
 18 OF 28
C4.0

- ***Replace Plan Sheets C4.0 through C4.3 with the attached.***
 - Cut/Fill volumes are now included in the Profile View on each sheet.

- CONSTRUCTION NOTES
1. CONSTRUCT ROAD PER TYPICAL SECTION 1/C1.0
 2. INSTALL STOP SIGN. SEE SIGNING AND STRIPING PLAN
 3. CONSTRUCT ROAD PER TYPICAL SECTION 3/C1.0
 4. CONSTRUCT WATER QUALITY SWALE PER DETAIL 1/C5.0

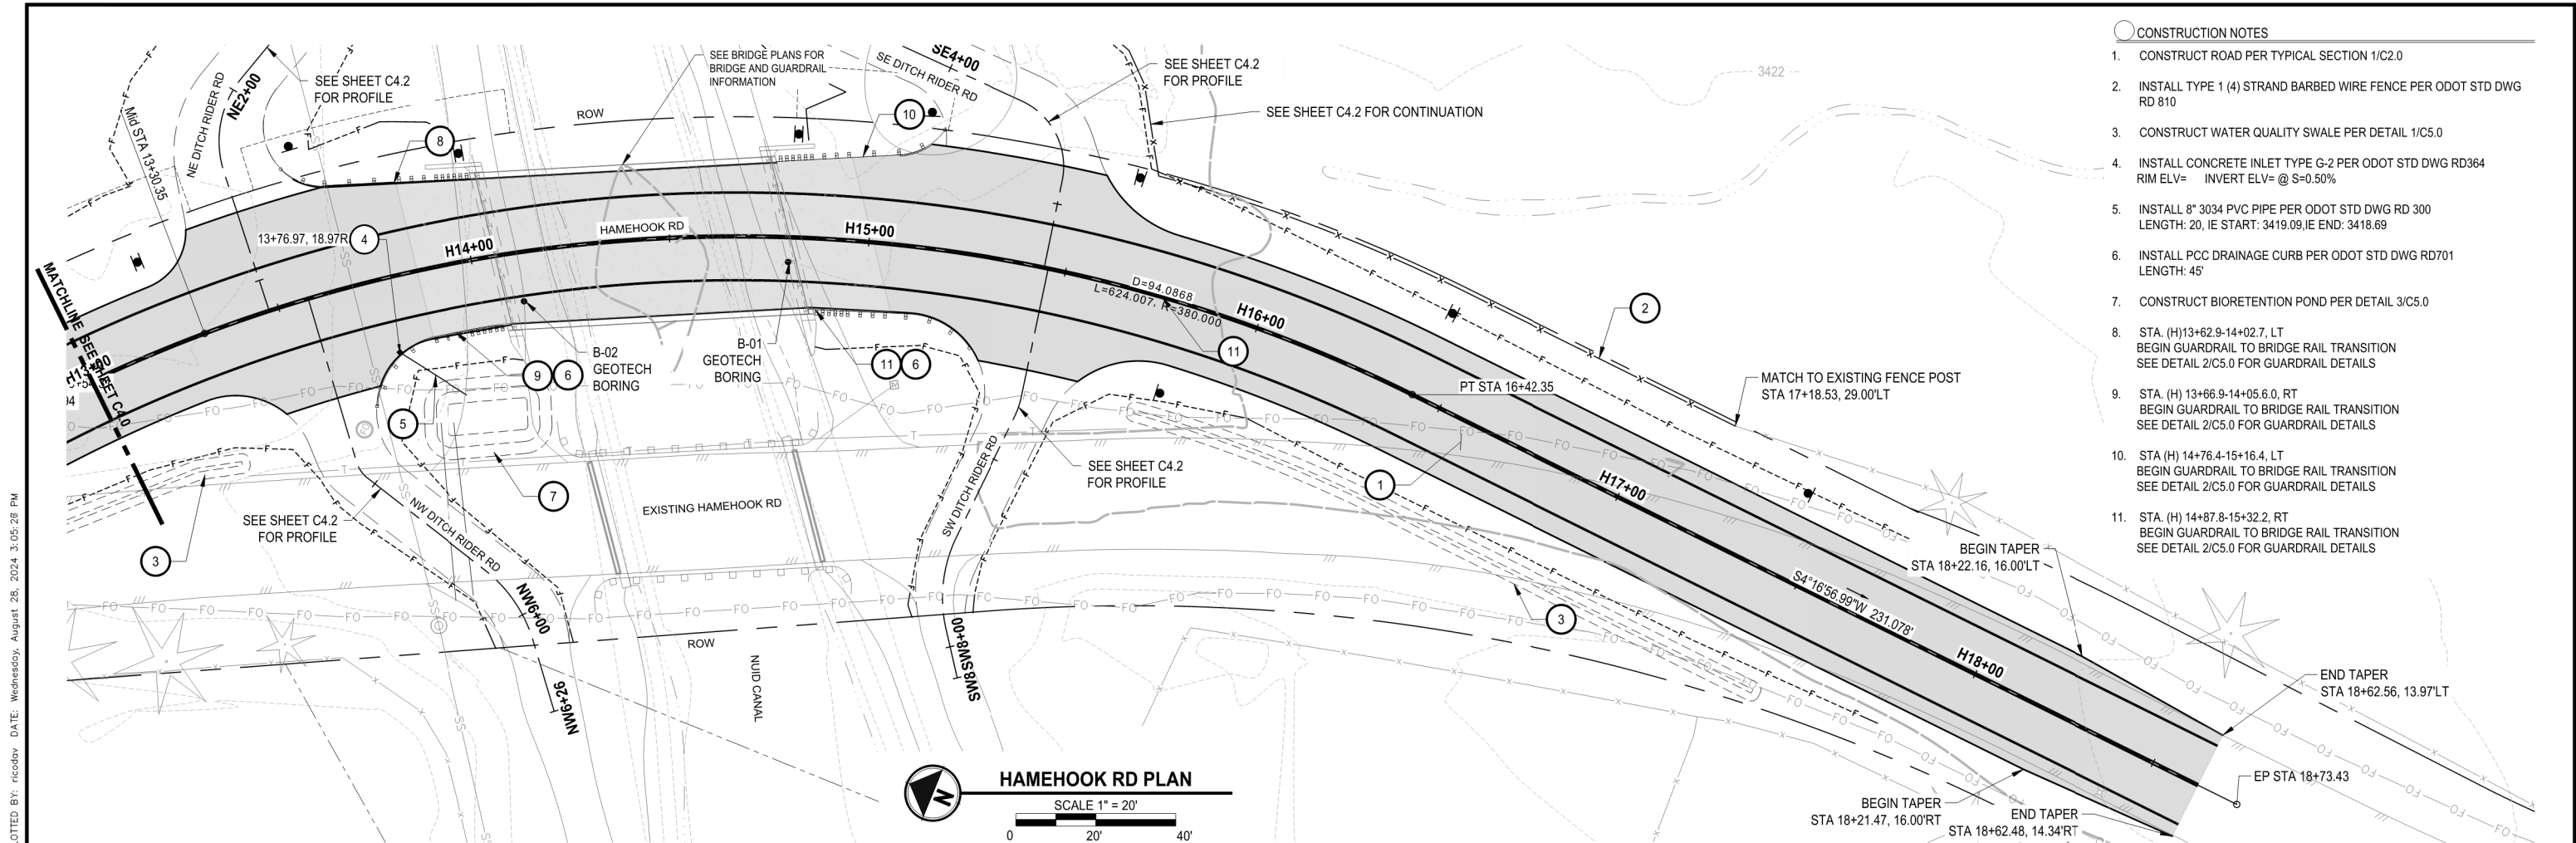
- CONSTRUCTION NOTES**
- CONSTRUCT ROAD PER TYPICAL SECTION 1/C2.0
 - INSTALL TYPE 1 (4) STRAND BARBED WIRE FENCE PER ODOT STD DWG RD 810
 - CONSTRUCT WATER QUALITY SWALE PER DETAIL 1/C5.0

- INSTALL CONCRETE INLET TYPE G-2 PER ODOT STD DWG RD364 RIM ELV= INVERT ELV= @ S=0.50%
 - INSTALL 8" 3034 PVC PIPE PER ODOT STD DWG RD 300 LENGTH: 20, IE START: 3419.09, IE END: 3418.69

- STA. (H) 13+66.9-14+05.6, RT BEGIN GUARDRAIL TO BRIDGE RAIL TRANSITION SEE DETAIL 2/C5.0 FOR GUARDRAIL DETAILS
 - STA (H) 14+76.4-15+16.4, LT BEGIN GUARDRAIL TO BRIDGE RAIL TRANSITION SEE DETAIL 2/C5.0 FOR GUARDRAIL DETAILS

- STA. (H) 14+87.8-15+32.2, RT BEGIN GUARDRAIL TO BRIDGE RAIL TRANSITION SEE DETAIL 2/C5.0 FOR GUARDRAIL DETAILS

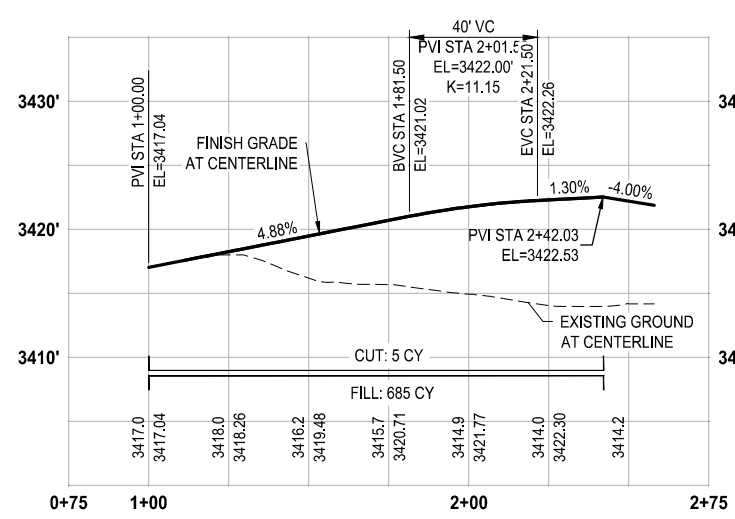
NE DITCH RIDER RD PROFILE
 H: 1"=30' V: 1"=8'

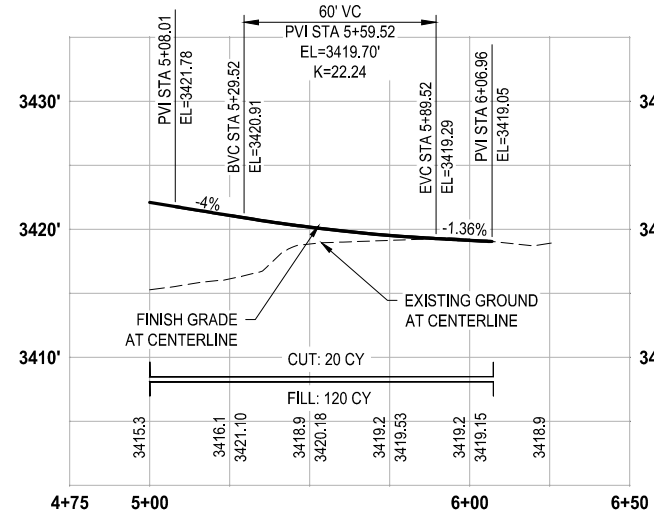
NW DITCH RIDER RD PROFILE
 H: 1"=30' V: 1"=8'

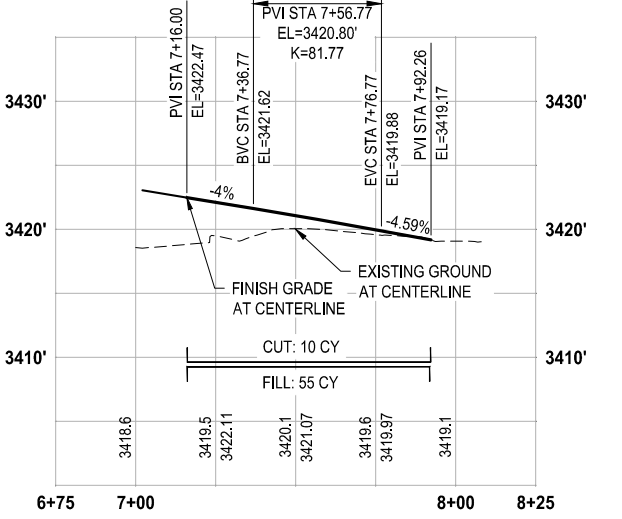
SW DITCH RIDER RD PROFILE
 H: 1"=30' V: 1"=8'

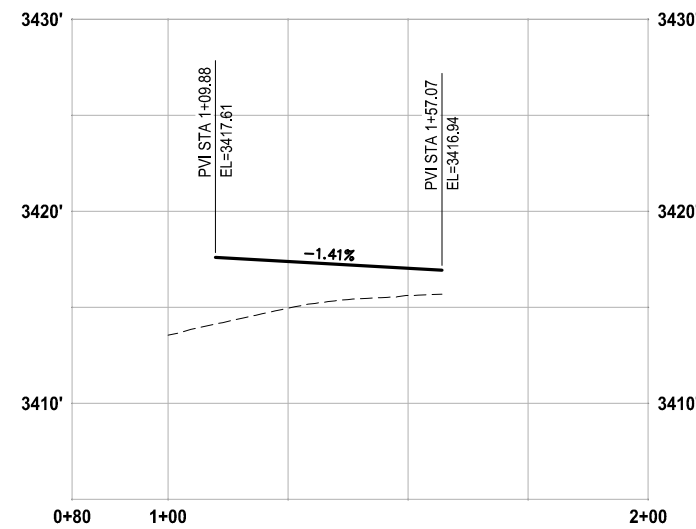
DRAWING NO.
 21 OF 28
C4.3

- CONSTRUCT PIONEER LOOP ROAD PER TYPICAL SECTION 3/C1.0

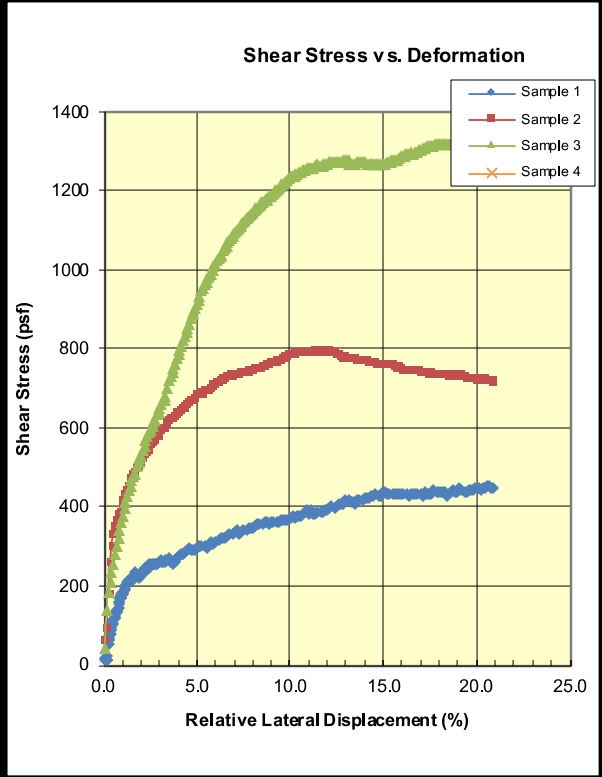
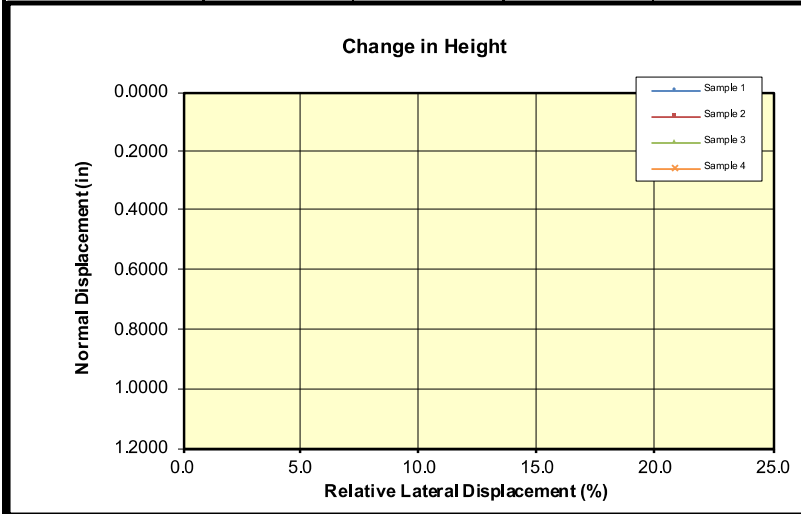
Specimen Data				
	1	2	3	4
Boring:	B-02	B-02	B-02	
Sample:	S-3	S-3	S-3	
Depth (ft):	5	5	5	
Visual Description:	Dark Brown Silty SAND	Dark Brown Silty SAND	Dark Brown Silty SAND	
Normal Load (psf)	500	1000	1500	
Dry Mass of Specimen (g)	94.2	94.4	94.5	
Initial Height (in)	1.00	1.00	1.00	
Initial Diameter (in)	2.41	2.40	2.41	
Initial Void Ratio	1.142	1.120	1.135	
Initial Moisture (%)	16.8	16.6	16.6	
Initial Wet Density (pcf)	91.9	92.7	92.0	
Initial Dry Density (pcf)	78.7	79.5	78.9	
Initial Saturation (%)	39.8	40.1	39.4	
Δ Height Consol (in)	0.0108	0.0270	0.0523	
At Test Void Ratio	1.119	1.063	1.023	
At Test Moisture (%)	34.3	32.0	30.5	
At Test Wet Density (pcf)	106.9	107.8	108.7	
At Test Dry Density (pcf)	79.6	81.7	83.3	
At Test Saturation (%)	82.9	81.3	80.6	
Strain Rate (%/min)	1.0	1.0	1.0	
Strengths Picked at	Peak	Peak	Peak	
Shear Stress (psf)	451	794	1329	
Δ Height (in) at Peak				
Ultimate Stress (psf)

Phi (deg)	38.9	Ult. Phi (deg)	
Cohesion (psf)	50	Ult. Cohesion (psf)

Remarks: *DS-CU* A fully undrained condition may not be attained in this test. Δ H is not measured during undrained direct shear tests.

Native, silty-sand was encountered extending below the existing fill up to depths of between 12- to 13-feet bgs in the borings. Gradation tests indicate the native soil generally classifies as silty-sand, according to the USCS. Based on relative density recordings using SPT's, the native silty-sand was generally very loose to dense. Where tested, the soil samples contained between 19 to 21 percent clay- and silt-sized particles, had moisture contents ranging between 16.2 to 24.7 percent, and contained varying amounts of gravel-sized particles. Based on direct shear testing, the native soil has an undrained angle of internal friction (Phi) of 38.9° and a cohesion of 50 pounds per square foot (psf). The silty-sand was moist, brown, and fine- to coarse-grained.

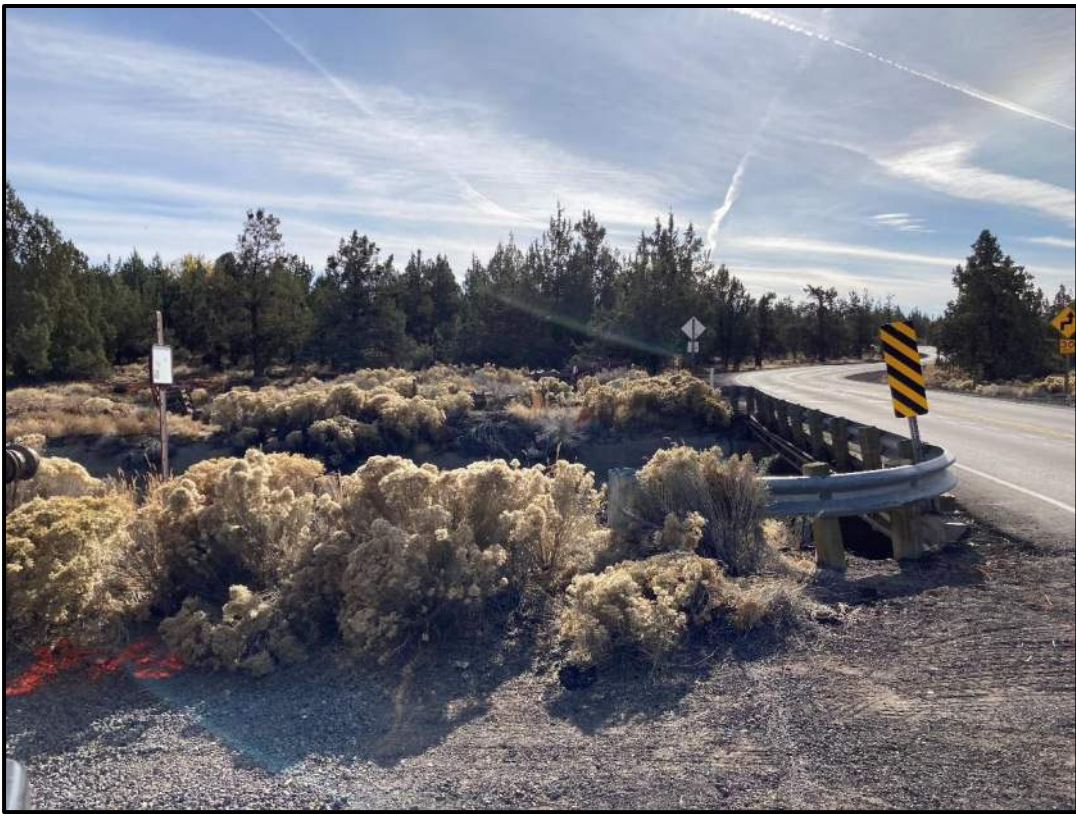
Existing conditions during exploration.

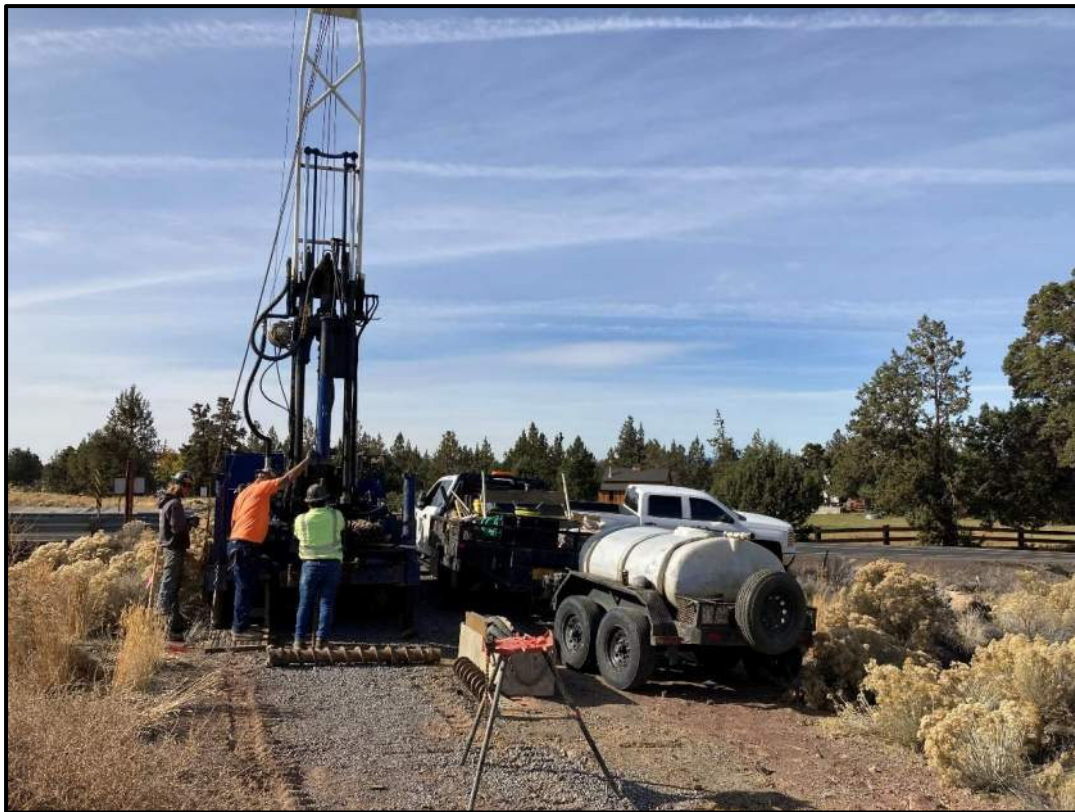
Geotechnical borings performed with truck-mounted CME 850 drilling rig.

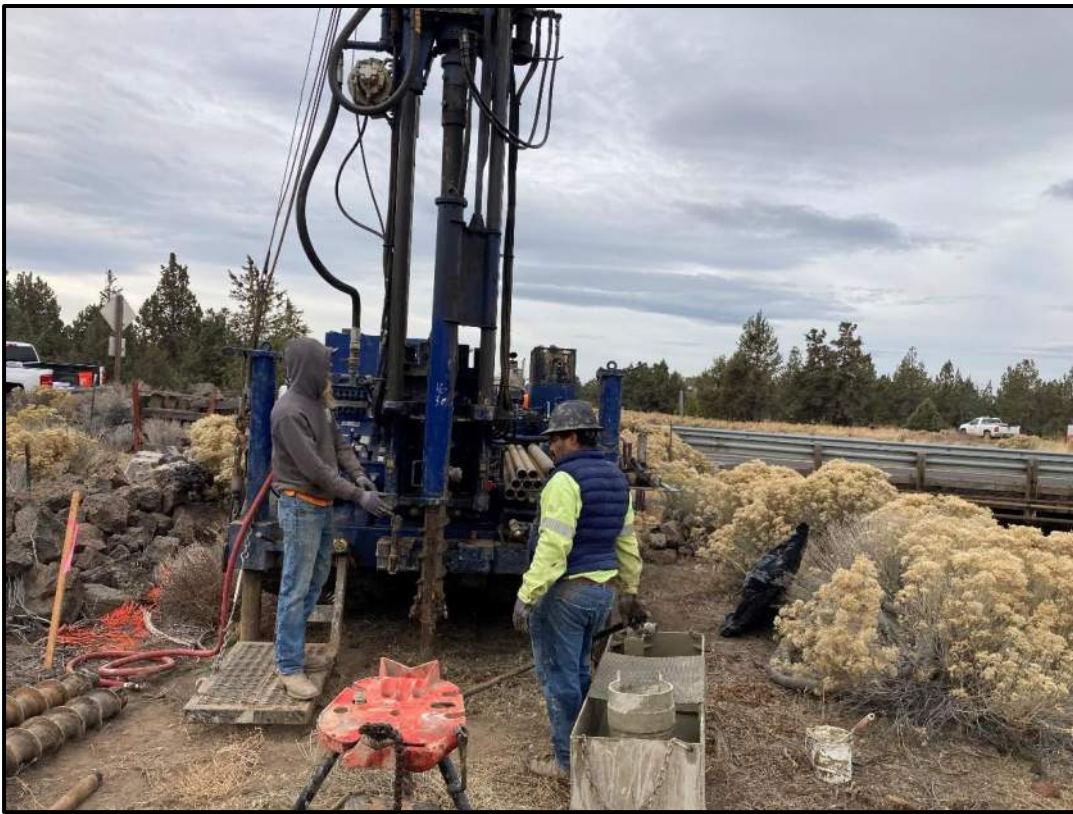
Drilling methods included hollow stem auger and HQ-wireline coring.

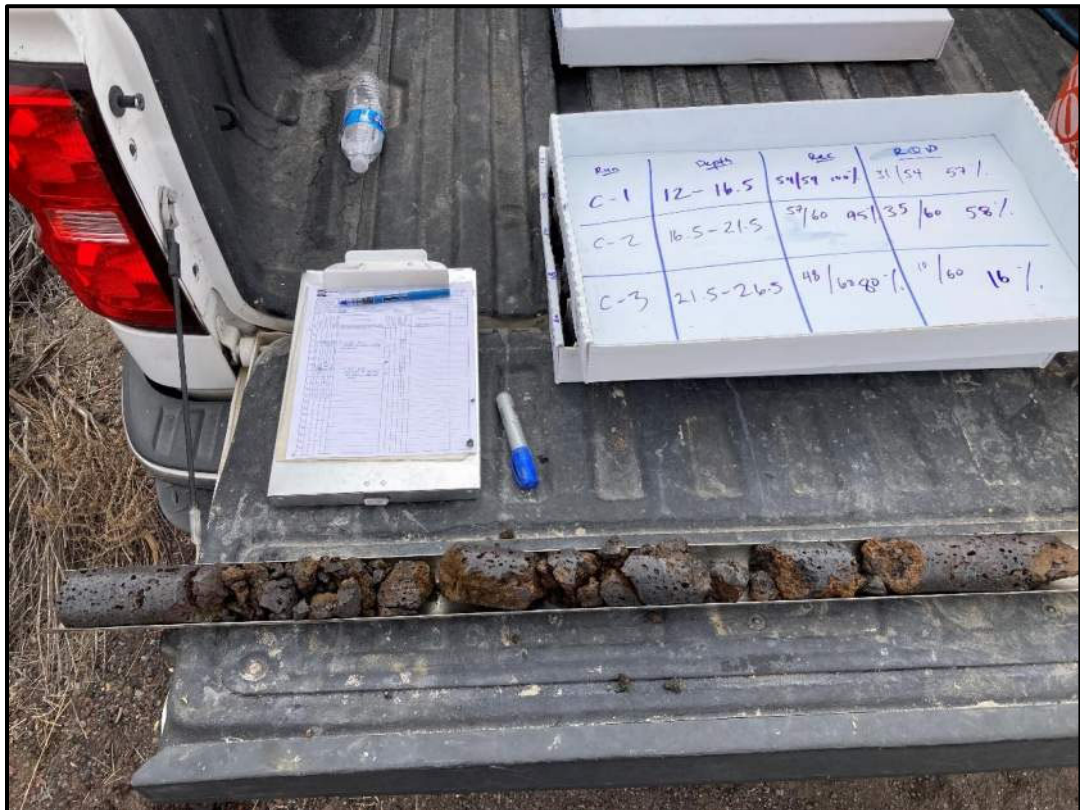
B-01 core run C-3 from 21.5 to 26.5-feet bgs. Note very poor rock quality.

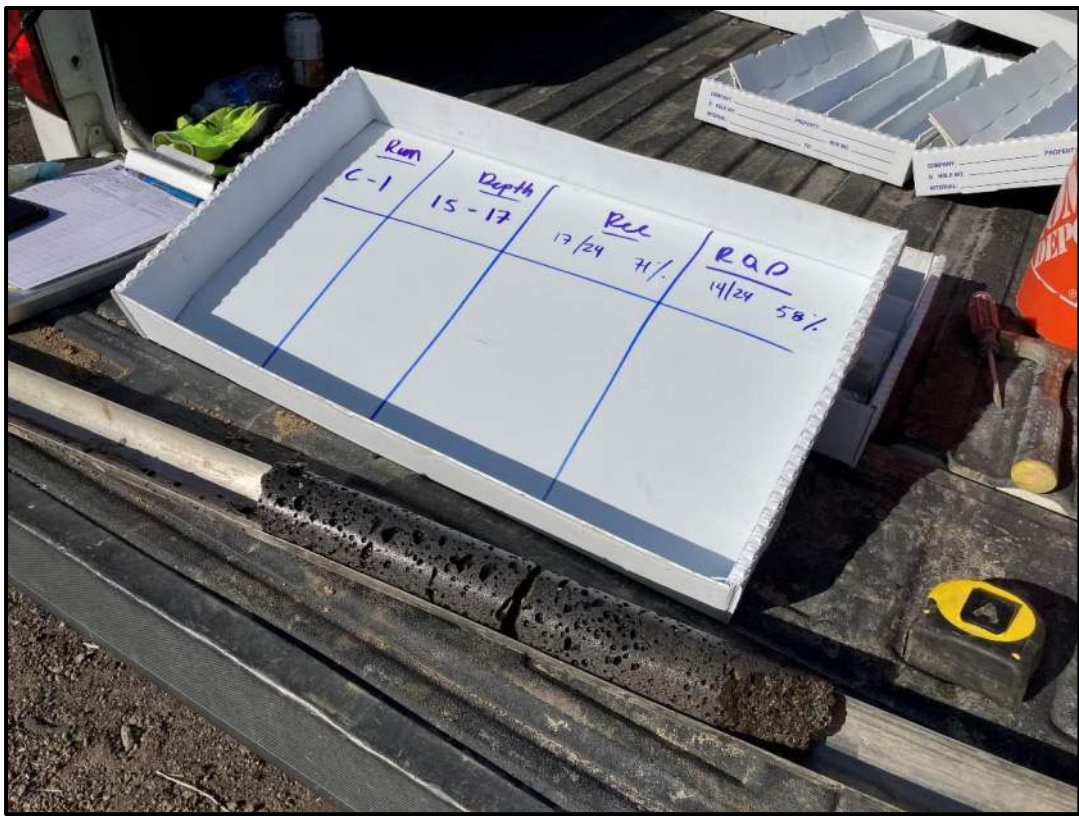
B-02 core run C-1 from 15 to 17-feet bgs. Note abundant and large vesicles.

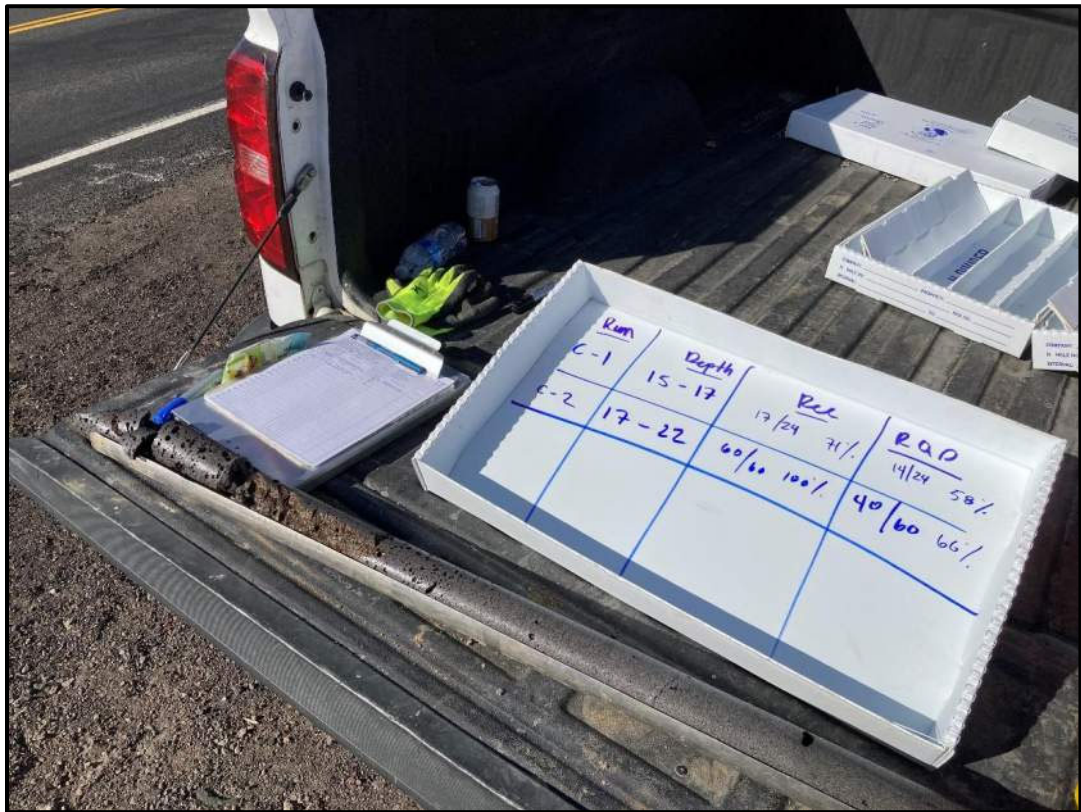
B-02 core run C-2 from 17 to 22-feet bgs. Note transition to massive rock with very few vesicles.
